Savvy Real Estate Inspections

Customer
Frank Spears

Address
5400 Executive Blvd
San Antonio Tx

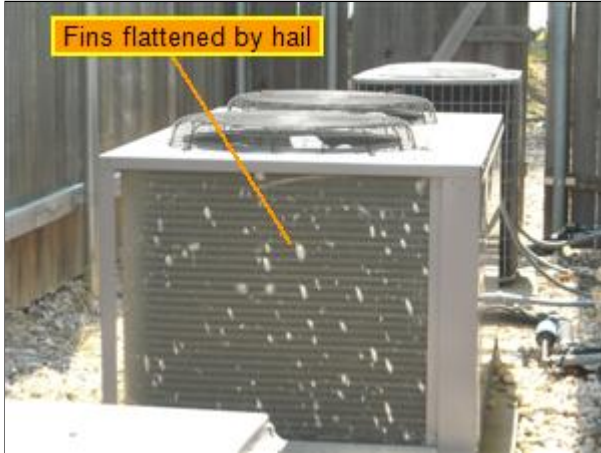
6.2 Picture 1

- ⚠ (2) The cooling fins on the exterior condensers show hail damage. These fins help to keep the motors cool. Re-aligning these fins by a professional is recommended for proper performance.
